TRAFFIC REPORT FOR CLIVE AVENUE AND RAGLETH ROAD, CHURCH STRETTON

March to May 2026

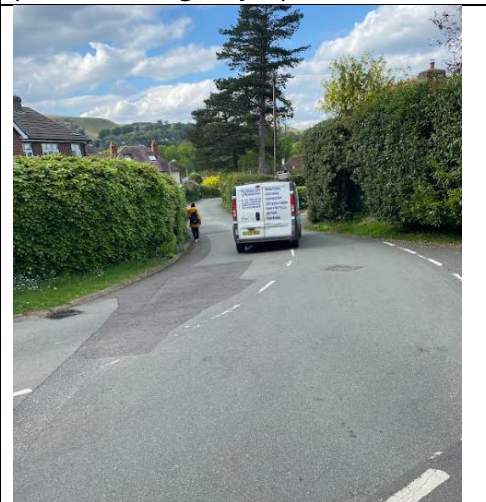
6 May 2026 – vehicle came fast around corner and pedestrian wearing headphones! No visibility at all
